stormwater infiltration

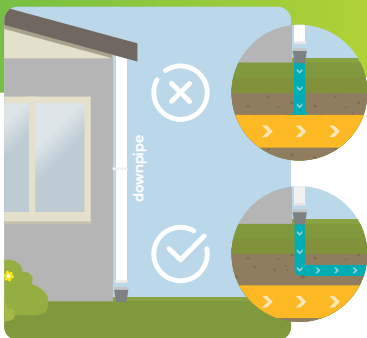
Downpipes must be connected to stormwater, not the sewer. A qualified plumber can check this using a smoke or flow test

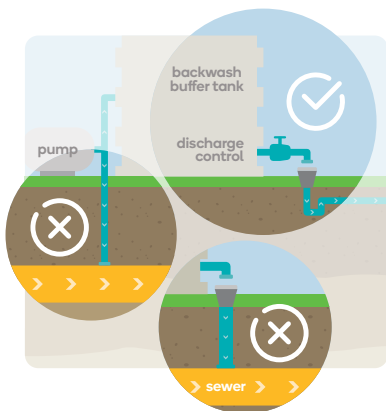
Pool backwash rate must be limited to no more than 0.5 L/s. A buffer tank or pump with restrictor can achieve this.

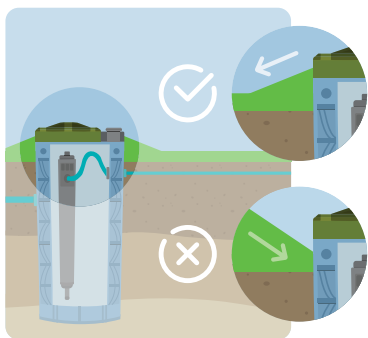
Landscaping around Altogether's collection tank must drain away from the lid, not towards it.

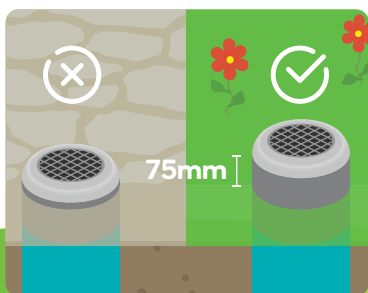
Overflow relief gully must be at least 75mm above surrounding ground level.
